Flow-Liner®

“Potable Water Solution”

With a Pipe Lining Technology Answer

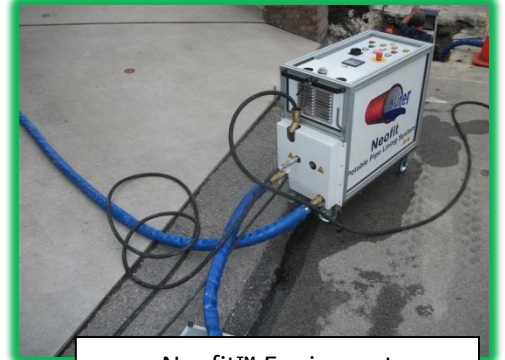
Neofit™ Equipment

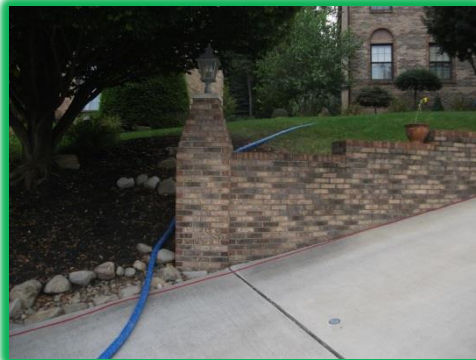
Neofit™ Equipment Set-up from
curbside to house

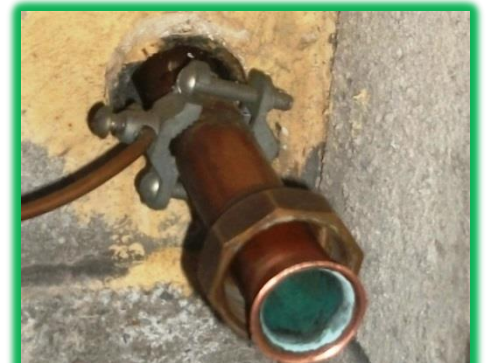
Water service line after
Neofit™ installed

The water service line, from city curb stop to the house, was successfully lined without excavation or disruption to the newly installed concrete heated driveway. The line was tested and placed back in service the same day. Customer was very satisfied with the finished project.
