# Flow-Liner®

## With A CIP-Conduit® Lining Solution

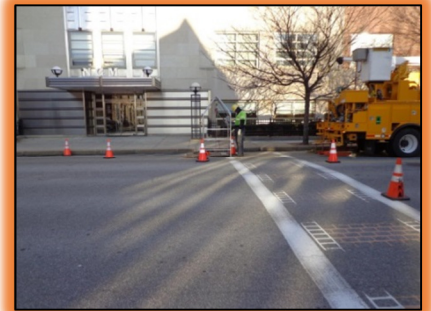
Manhole Access in the Street

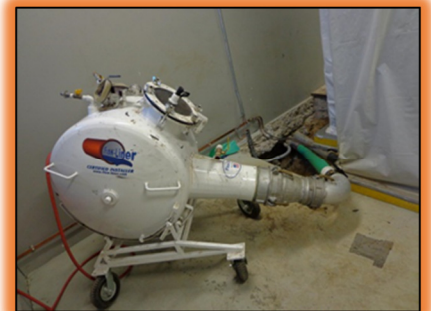
Flow-Liner® Equipment Set-up

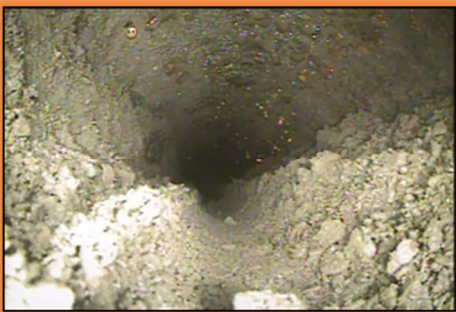
The electrical conduits were full of debris and heavy scale. Due to the debris and heavy scale, the electrical contractor was unable to install new power cables in the conduit. Excavation and replacement would have been costly and disruptive to the facility.

Debris and heavy scale build-up in conduits prior to lining

Using Flow-Liner® technology, a Flow-Liner Certified Installer prepared and installed the CIP-Conduit® Lining System in the two 4 inch electrical conduits.

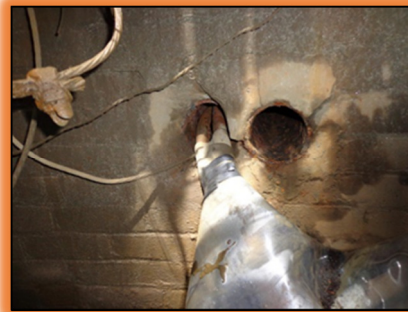
Conduit access inside manhole vault

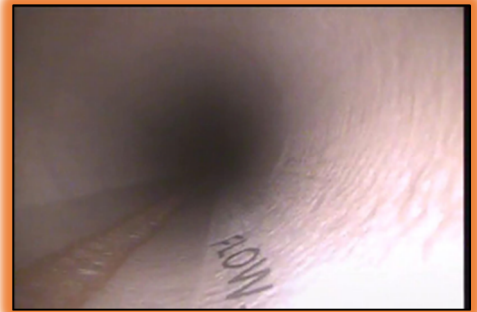
The electrical conduits were successfully lined with no disruption to the facility or its occupants. The Project Manager with F. H. Hamblet, Inc. was very pleased with the results and commented:

4 inch conduits after Flow-Liner® CIP Conduit Lining installed
